# Geological Hazards in Samtskhe-Javakheti Region (Georgia)

Gaprindashvili George<sup>1,2</sup>, Gerkeuli Tamaz<sup>1</sup>, Tsereteli Emil<sup>1,2</sup>, Gaprindashvili Merab<sup>1</sup>

<sup>1</sup>Department of Geology, National Environmental Agency, Ministry of Environment and Natural Resources Protection, Tbilisi, Georgia

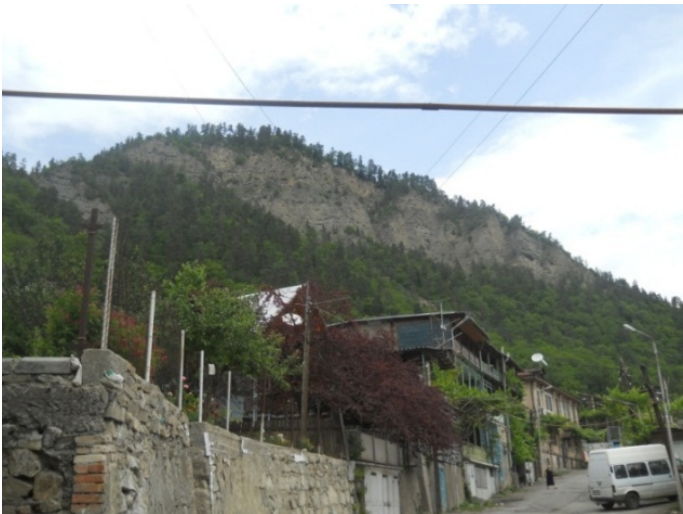
Borjomi city—still under the danger of rockfall are residential buildings which located at the foot of almost vertical cliff with height of 50 - 60 m, situated on the left bank of river Mtkvari (**Figure 6**). The exposition of cliff is southern-eastern, geologically it is represented by Paleogene-Early Eocene (BorjomiFlysch) marls, sandstones and tuffs. As a result of physical erosion of rocks, fall of materials with various sizes and also separate clods is taking place. 3 years ago, on the same street, 20-tonne clod felt and damaged residential building. In 50s of previous century, at the slope foot, for the purpose of population protecting, 200 - 220 m long trench was dug, in which crumbled materials were accumulated. This trench now is filled and lost its function. For the purpose of prevention it is necessary to clear the trench and periodically clear the slope.

**Figure 6.** City Borjomi, rockfall area.

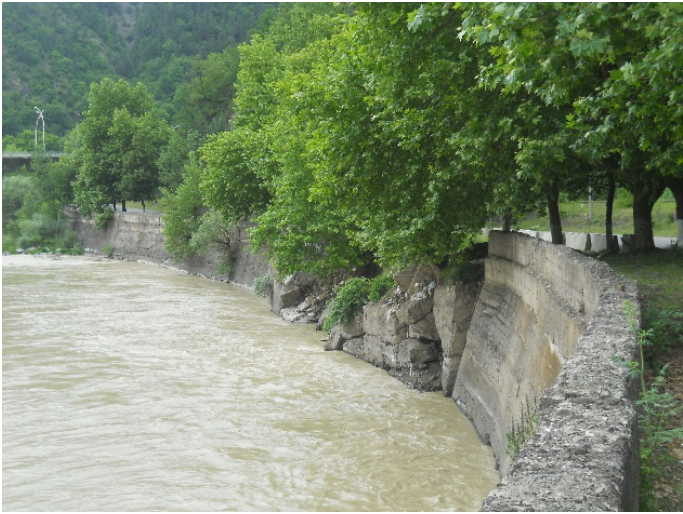
In the Orbeliani street sustaining walls of 12-13-10 and 15 m long, ruined and damaged in 2013, were restored. Sustaining wall of 25 m long, located on the right bank of river Mtkvari, should be restored (**Figure 7**).

**Figure 7.** Riv. Mtkvari right bank erosion.

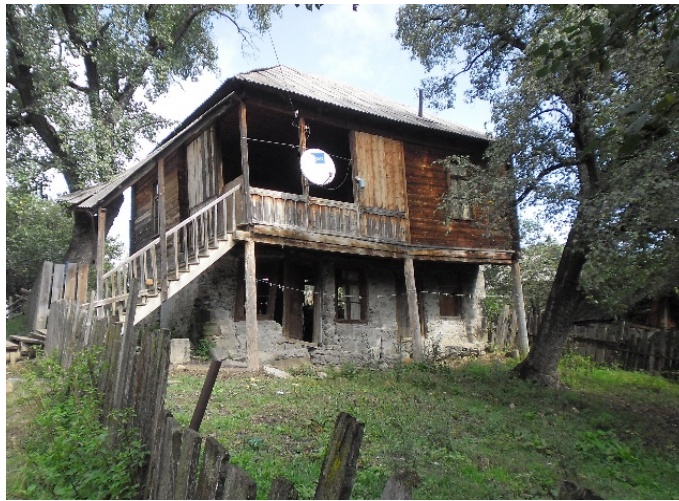
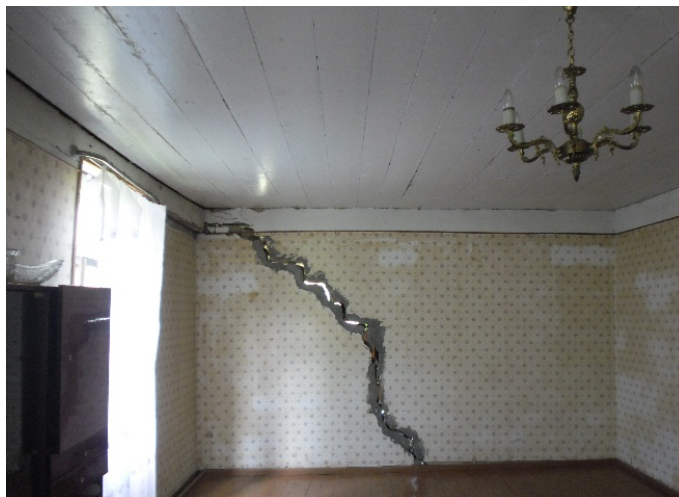
Village Dgvari—in this village landslide of modern generation is active. Its area is up to 300 ha. The landslide is plastic, creeping type. Its length is 2.0 km, width—1.5 km, thickness—15 - 20 m. In this village all buildings are damaged (**Figure 8**, **Figure 9**).

**Figure 8.** Village Dgvari, house damaged by landslide.

**Figure 9.** Village Dgvari, house damaged by landslide.

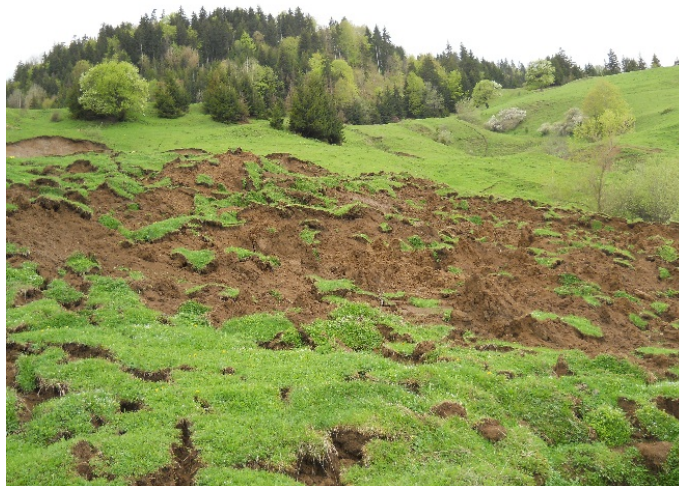
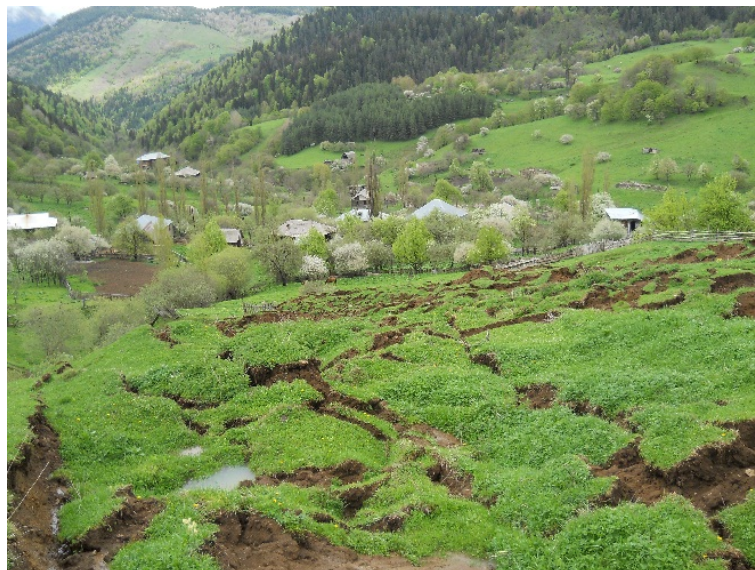
Village Didi Mitarbi. Landslide developed in the spring 2012 is in phase of temporary stability. It is sliding type, length is 120 m, width in the tongue part—60 m, average width—40 m. Area is 4500 m<sup>2</sup>. Basis of this landslide are a homestead lands of local population at the foot of it. In previous year recommendation was issued for the purpose of process prevention which was not implemented. In case of activation 3 residential buildings at the foot of the slope will be endangered (**Figure 10**, **Figure 11**).

**Figure 10.** Village Didi Mitarbi landslide.

**Figure 11.** Village Didi Mitarbi landslide.

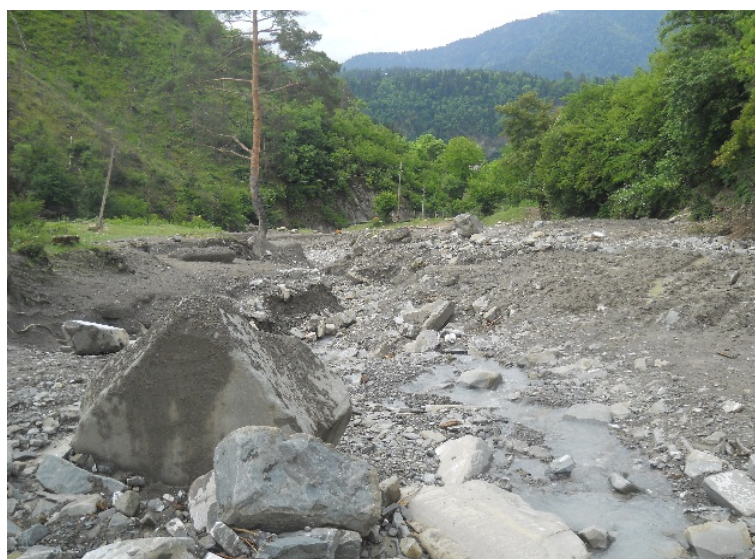
Debris flow broad gully of river Naghvarevi's water—in August 2008, as a result of Russian aggression, fire occurred on the territory of Borjomi municipality which damaged and completely destroyed woodland area up to 1000 ha. Intense erosion of slopes began. On the both slopes of broad gully landslide processes were developed. Almost all dry erosion broad gullies and ravines are able to form mudflows. On the bed of broad gully huge amount of terrigenous materials is accumulated (**Figure 12**) which is creating a danger to the population of village Daba. For the purpose of protection from debris flow/mudflows it is of urgent necessity to clear the bed of Naghvarevi broad gully so that in the period of next mudflows' proceeding which will inevitably happen village population should be protected from expected catastrophes.

**Figure 12.** Naghvarevis Tskali debris flow.

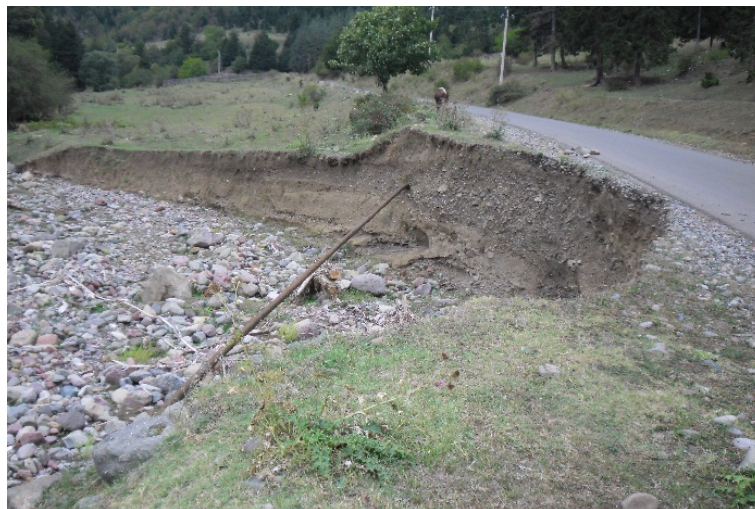
On the road between villages Sakire and Dviri, in the spring of 2014, during a flood, river Sakirula damaged roadway in 5 sites and created danger to its functioning (**Figure 13**).

**Figure 13.** Sakire-Dviri damaged road.

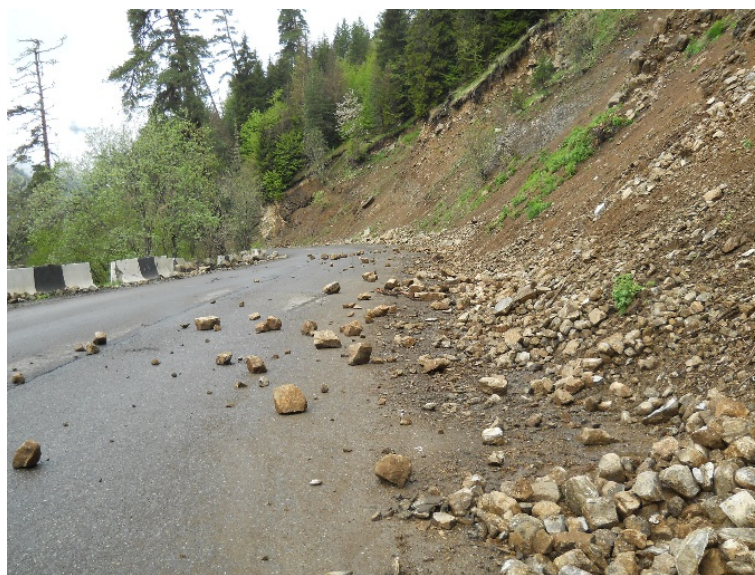
On this section the landslide which has an area of 1.9 ha, is periodically damaging the section of roadway with the length of 125 m and endangers cemetery located above the road. For the purpose of prevention it is necessary to regulate surface waters and carry out forestation of the slope. On the same road rockfall site is fixed which temporarily closed roadway (**Figure 14**).

**Figure 14.** Rockfall (Borjomi-Bakuriani road).

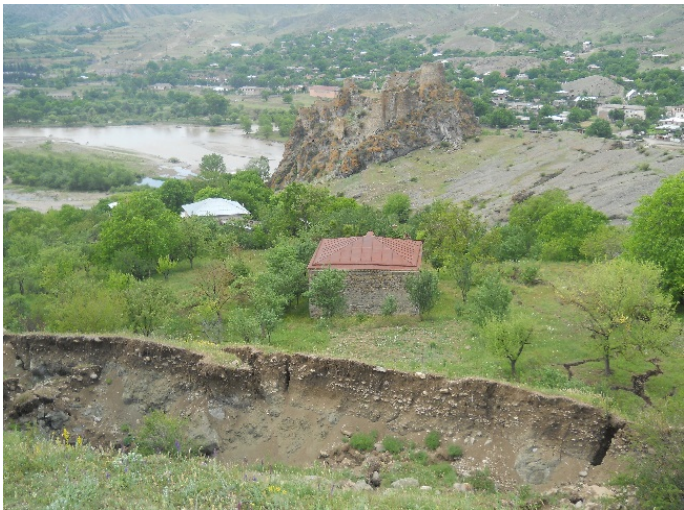
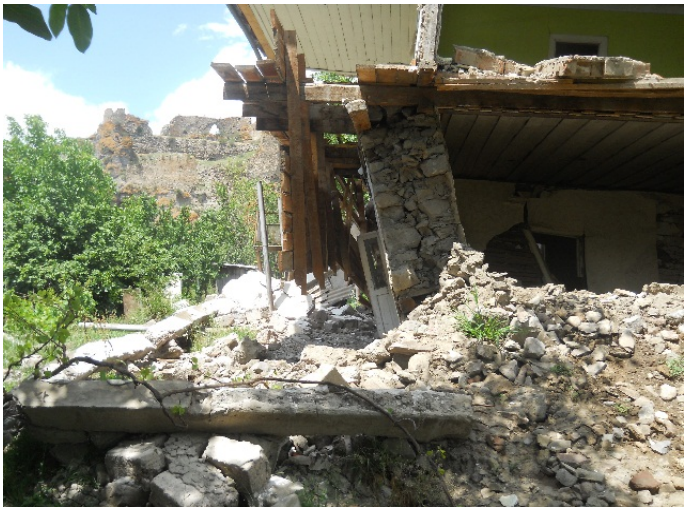
Village Gaghma Atskuri—landslide developed near the Atskhuri castle is still active (area—17.5 ha). This block type landslide developed during the earthquake of May 7, 2012. The length of landslide is 300 m, average width—up to 100 m, expected thickness—5 - 6 m. In the village 9 residential buildings are ruined, 12 households are under the high risk (**Figure 15**, **Figure 16**) [3] [4].

Figure 15. Village Gaghma-Atskuri landslide.

Figure 16. Village Gaghma-Atskuri landslide, destroyed house.

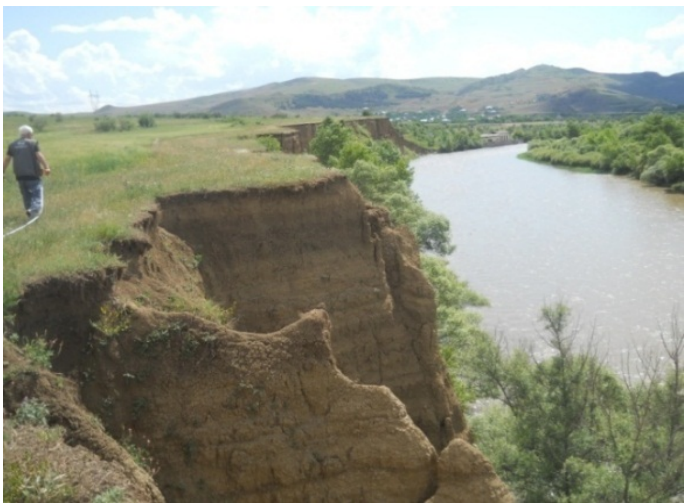
Village Thiseli—Landslide developed on the territory of this village is periodically active. Its area is 11.0 ha. This landslide during various occasions damaged 16 residential buildings, 7 buildings require repair which conditions might be worsened. In the Tkemlana-Sakuneti section on the bank of river Mtkvari is still alarming situation where intense erosion of bank is occurring on the length of 850 m (**Figure 17**) as a result of which vertical

Figure 17. Riverbank erosion (Tkemlana-Sakuneti section).

cliff of 15 - 18 m height is developed, and agricultural lands are eroded. For the purpose of prevention it is necessary to carry out coast-protecting works.

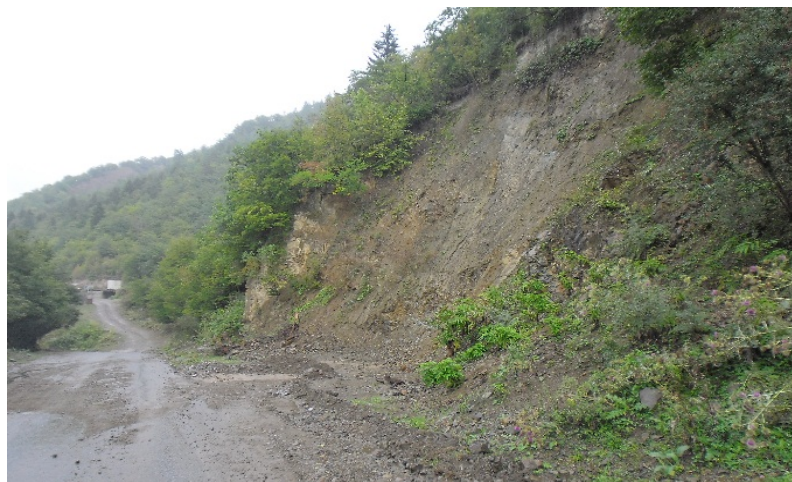
Near the village Chobiskhevi, in the spring of 2014, debris fall from the slope for several hours completely closed road on the length of 35 m (**Figure 18**).

**Figure 18.** Rockfall (Chobiskhevi road).

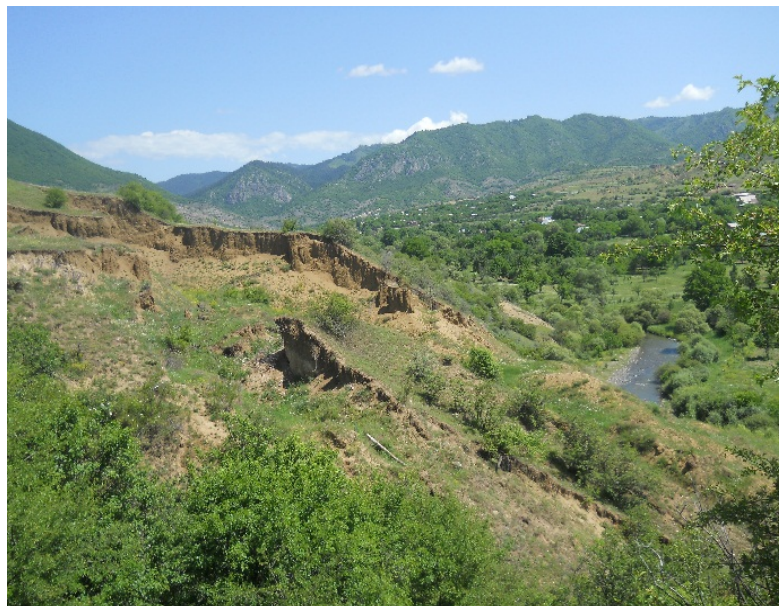
Village varkhani. Here regressive landslide developed on the right slope of river Otskhe is active. Its length along with valley is 130 m, width—from 80 to 120 m. On the slope early and newly created blocks are dumped (**Figure 19**) [6].

**Figure 19.** Varkhani landslide.

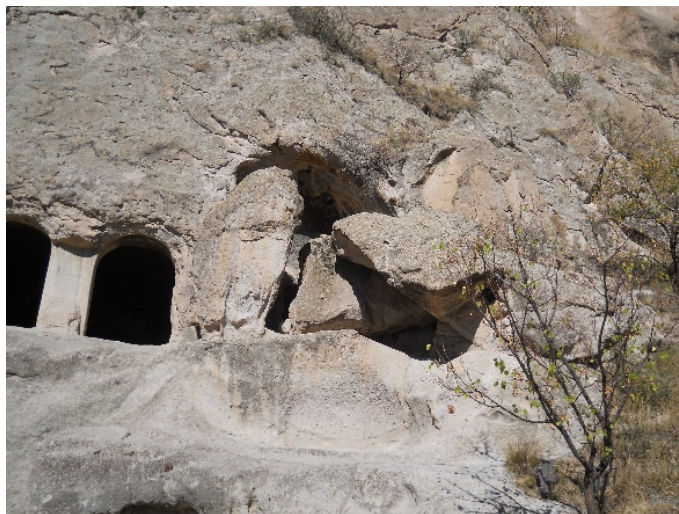
Rock massif situated on the territory of Vardzia monastery complex is a left slope of canyon-like valley of river Mtkvari built by Mio-Pliocene tuffs, tuff breccias and lava cover. Its absolute height is 1200 - 1600 m. Vardzia rock massif is an active gravitational zone, rockfalls developed here are creating danger to the communications of monastery complex (cells cut in the cliff, tourist paths, car parking, etc.). For the complex which is cut in the cliff and other communications, upper horizon of main cliff (on façade side) is especially dangerous where, because of structural-textural peculiarities of volcanogenic rocks, blocks and clod are forming, having potential of gravitational movement (**Figure 20, Figure 21**). It is necessary to repair damaged parts of concrete trench located at the brow of cliff, adjacent to the rubble-concrete wall, also collect waters flew down from the slope above the gravitational cliff, and transfer them via the pipes to the base of slope, in the floodplain of river Mtkvari.

**Figure 21.** Rockfall processes in Vardzia complex.
