# Geological Hazards in Samtskhe-Javakheti Region (Georgia)

Gaprindashvili George<sup>1,2</sup>, Gerkeuli Tamaz<sup>1</sup>, Tsereteli Emil<sup>1,2</sup>, Gaprindashvili Merab<sup>1</sup>

<sup>1</sup>Department of Geology, National Environmental Agency, Ministry of Environment and Natural Resources Protection, Tbilisi, Georgia

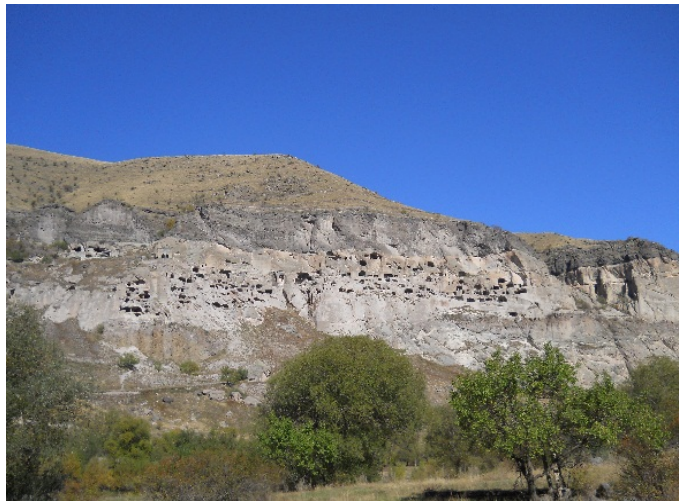
Rock massif situated on the territory of Vardzia monastery complex is a left slope of canyon-like valley of river Mtkvari built by Mio-Pliocene tuffs, tuff breccias and lava cover. Its absolute height is 1200 - 1600 m. Vardzia rock massif is an active gravitational zone, rockfalls developed here are creating danger to the communications of monastery complex (cells cut in the cliff, tourist paths, car parking, etc.). For the complex which is cut in the cliff and other communications, upper horizon of main cliff (on façade side) is especially dangerous where, because of structural-textural peculiarities of volcanogenic rocks, blocks and clod are forming, having potential of gravitational movement (**Figure 20, Figure 21**). It is necessary to repair damaged parts of concrete trench located at the brow of cliff, adjacent to the rubble-concrete wall, also collect waters flew down from the slope above the gravitational cliff, and transfer them via the pipes to the base of slope, in the floodplain of river Mtkvari.

**Figure 20.** Vardzia monastery complex (general view).
