Present Landscapes and Their Ecological States in the Ore Mining Region of Chiatura

Elene Salukvadze, Tamila Chaladze, Tamar Khardziani, Ketevan Gogidze. Present Landscapes and Their Ecological States in the Ore Mining Region of Chiatura. *Earth Sciences*. Special Issue: New Challenge for Geography: Landscape Dimensions of Sustainable Development. Vol. 6, No. 5-1, 2017, pp. 8-16. doi: 10.11648/j.earth.s.2017060501.12

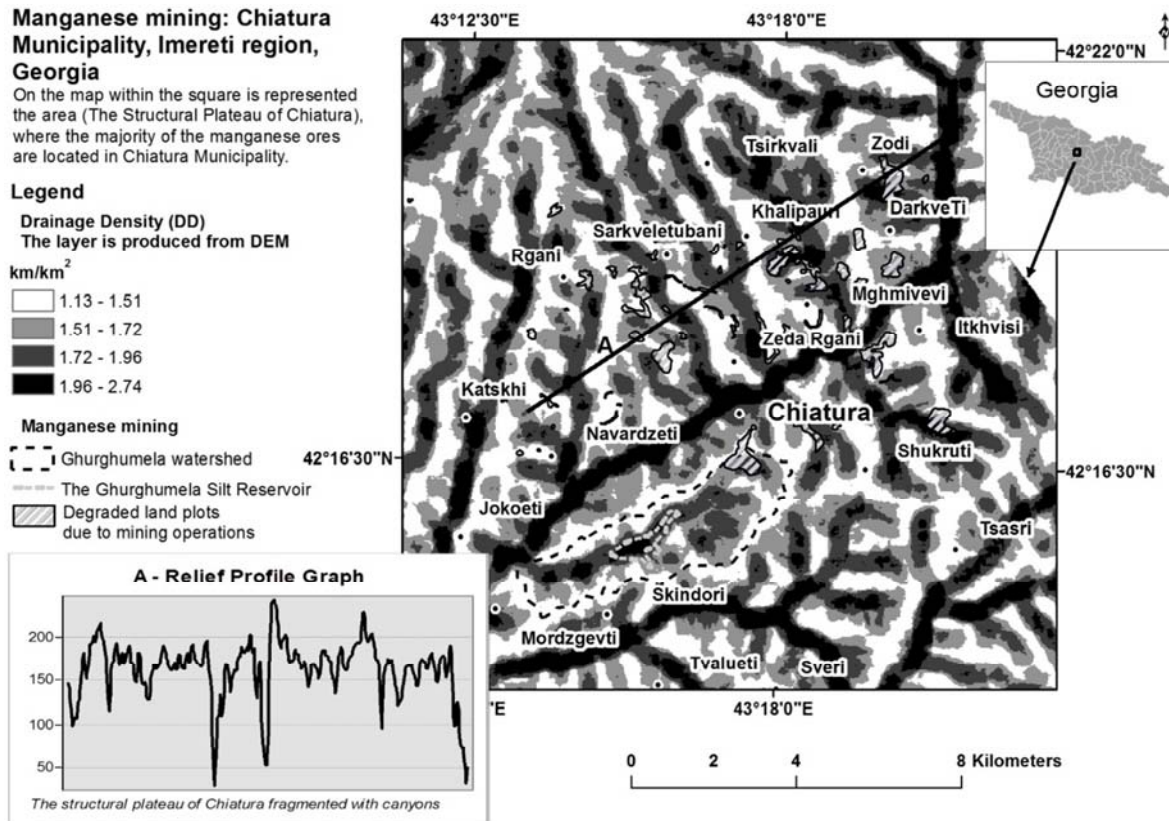
Figure 2. Internal waters and environmental degradation.

main river is the Kvirila and its main tributaries are: Jruchula, Sadzalikhevi, Katskhura, Itkhvisistskali, Shouletisghele, Shukrutistskali, etc. The gorge of the relatively long river Ghurghumela is used for precipitating the manganese. There is a reservoir (Fig. 2) built in the gorge. The industrial waste water left after the process of ore washing contains a huge amount of suspension particles and manganese compounds. In the past the silt flew from the central flotation plants through the silt ducts (pipes), the manganese concentrate was

separated out and the remaining silt was run to the so called Ghurghumela Reservoir. There the silt was precipitated and the purified water was used again. Nowadays none of the ore-dressing plants have any treatment facilities, whereas the old ones are out of order. The Ghurghumela Silt Reservoir is inactive at present and it can cause a big hazard as its embankments may collapse in this seismically active, landslide and complicated relief zone.

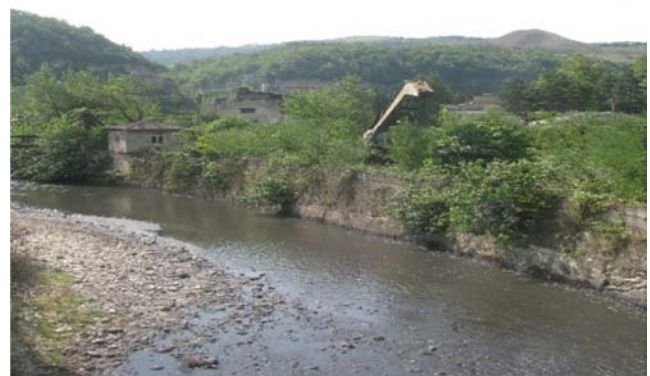
Figure 3. The river Kvirila permanently gets polluted with manganese.

Within the boundaries of Chiatura Municipality the river Kvirila is highly polluted (Fig. 3, Fig. 4). For dressing the most of the manganese is run to the river Kvirila and permanently gets polluted with manganese ore admixtures. The content of manganese ore in the river Kvirila is 10-12%. [6]. The river Kvirila is contaminated by the manganese ions. In 2009 at the entrance of Chiatura the recorded concentration of the manganese ions in the river Kvirila was 3.9 mg/l (maximum permissible concentration of manganese ions in water is 0.1 mg/l). According to the 2013 data in the waters of the river Kvirila the manganese concentration (6 folds) exceeded the maximum permissible concentration [7].

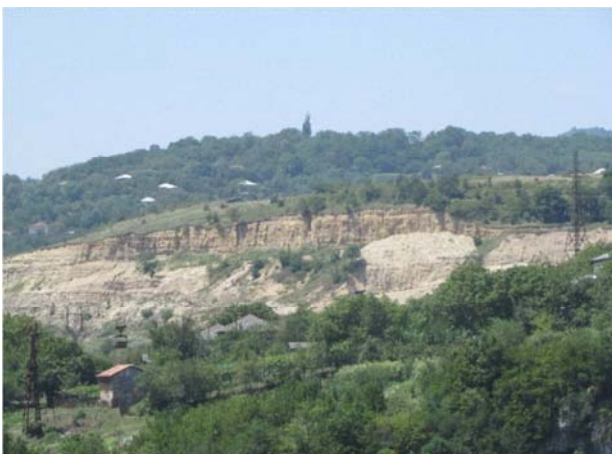
Figure 5. Rgani mining plateau.

The Company Georgian Manganese was charged with 158 832 GEL fine for “the damage caused to the environment as a result of the mining activities in the village of Rgani of Chiatura region” (Fig. 5). The damage was represented in the following: The trees and plants dug out during the activities on the processed territory were fully buried in the earth fill [9]. In the ore excavation and open cast mining areas any recultivation works are not carried out, the newly formed reliefs are neither leveled nor covered with soil layer, nor grass, trees and bushes are planted.

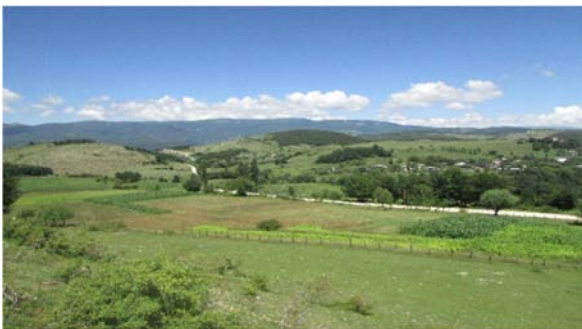
Figure 7. Landscapes low mountain plateaus.

In Chiatura almost every kind of landscapes has undergone changes as a result of technogenic influence. The most changed are the following landscapes: steep slopes of low mountains with oak and hornbeam forests, dark grey soils of washed down forests with low humus content and low mountain plateaus with oak and hornbeam forests, grey and meadow-carbonate soils (Fig. 7).

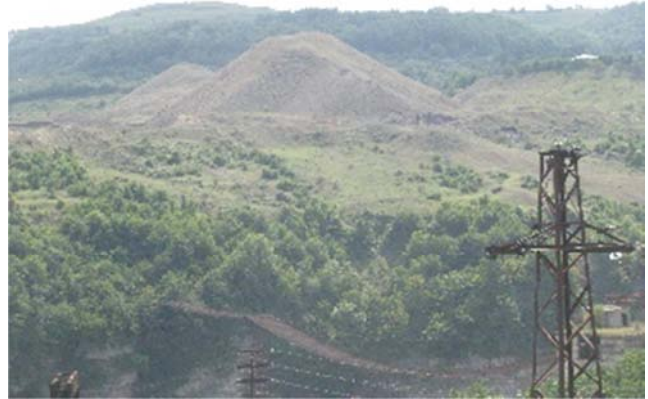
Figure 8. Waste heaps, manganese mines of Darkveti

On the territory immediately adjacent to the mining area the following modifications of anthropogenic landscapes are observed: pit and slag heap, slag heap, natural-technogenic (Fig. 8). Formation of technogeneous landscapes was qualitatively newly revealed when the heavy machinery used for the mining works changed the natural landscape as a result of anthropogenic influence (Fig. 9).
